DEPARTMENT OF TRANSPORTATION

Contract #: 04-0120F4Cty: SF/ALA Rte: 80 PM: 13.2/13.9File #: 69.28**WELDING INSPECTION REPORT****Resident Engineer:** Pursell, Gary**Address:** 333 Burma Road**City:** Oakland, CA 94607**Report No:** WIR-015608**Date Inspected:** 12-Jul-2010**Project Name:** SAS Superstructure**OSM Arrival Time:** 700**Prime Contractor:** American Bridge/Fluor Enterprises, a JV**OSM Departure Time:** 1900**Contractor:** Zhenhua Port Machinery Company, Ltd (ZPMC), Changxing Island **Location:** Shanghai, China**CWI Name:** Yang Bai Qiang**CWI Present:** Yes No**Inspected CWI report:** Yes No N/A**Rod Oven in Use:** Yes No N/A**Electrode to specification:** Yes No N/A**Weld Procedures Followed:** Yes No N/A**Qualified Welders:** Yes No N/A**Verified Joint Fit-up:** Yes No N/A**Approved Drawings:** Yes No N/A**Approved WPS:** Yes No N/A**Delayed / Cancelled:** Yes No N/A**Bridge No:** 34-0006**Component:** OBG**Summary of Items Observed:**

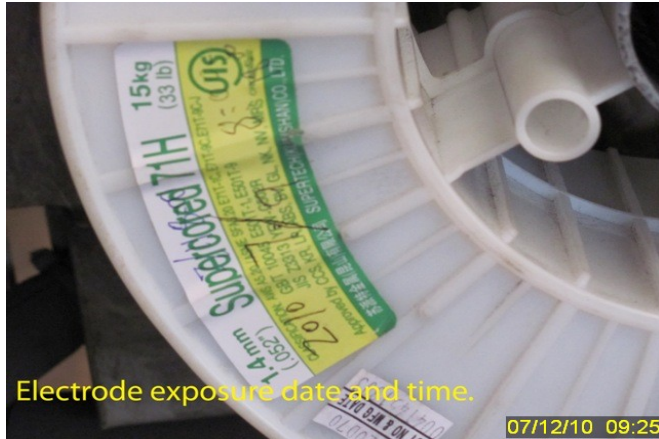
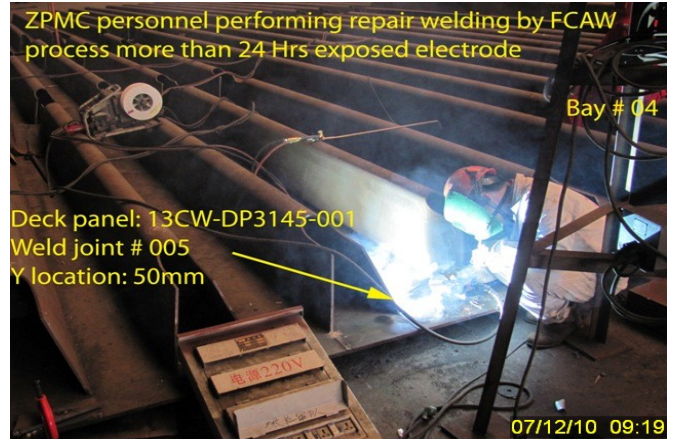
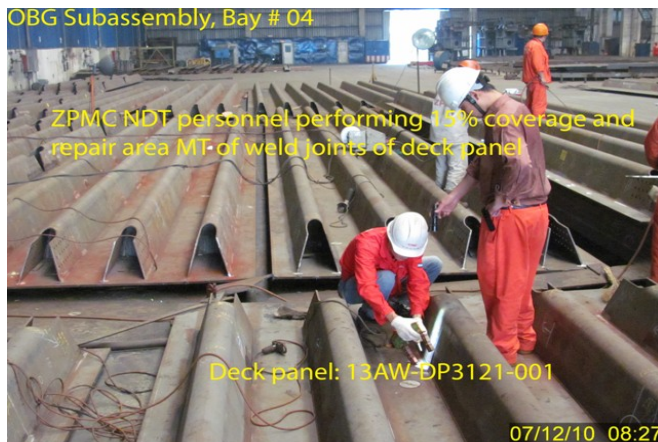
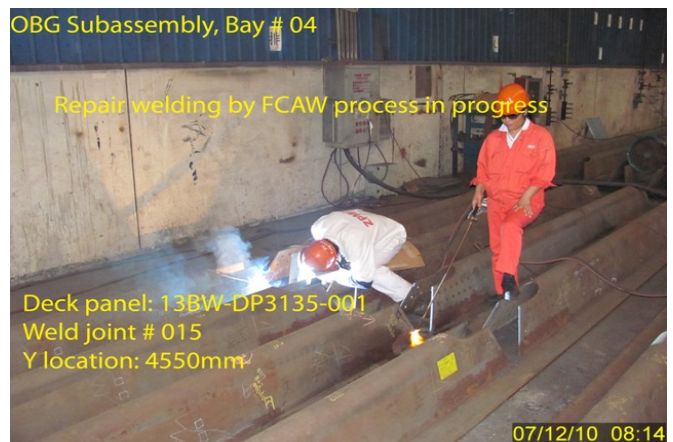
-ZPMC personnel performing Flux Cored Arc Welding (FCAW) on the U-rib to deck panel weld repairs with electrode wire that has been exposed for more than 70 hours.

-Approximately five tack weld locations were found welded with the over exposed electrode.

-The affected weld designations and respective Y locations are as follows:

DP3145-001-004, Y location = 50mm
DP3145-001-005, Y location = 50mm
DP3145-001-008, Y location = 650mm
DP3145-001-010, Y location = 50mm
DP3145-001-286, Y location = 1250mm

-This weld is Partial Joint Penetration (PJP) weld joining the U-rib to the deck plate.

-This weld is designated as Seismic Performance Critical Member (SPCM).

-This component is located in OBG fabrication bay 4.
For further information, please see the attached pictures below.
